## WGSL Sedimentation Basin Restoration Addendum Report

Subject: Sedimentation Basin Restoration Observation Report Addendum, Waimanalo  
Gulch Sanitary Landfill, Kapolei, HI

**Subject: Work Plan for Sedimentation Basin Restoration- Waimanalo Gulch  
Sanitary Landfill, Ewa Beach, Oahu, HI**

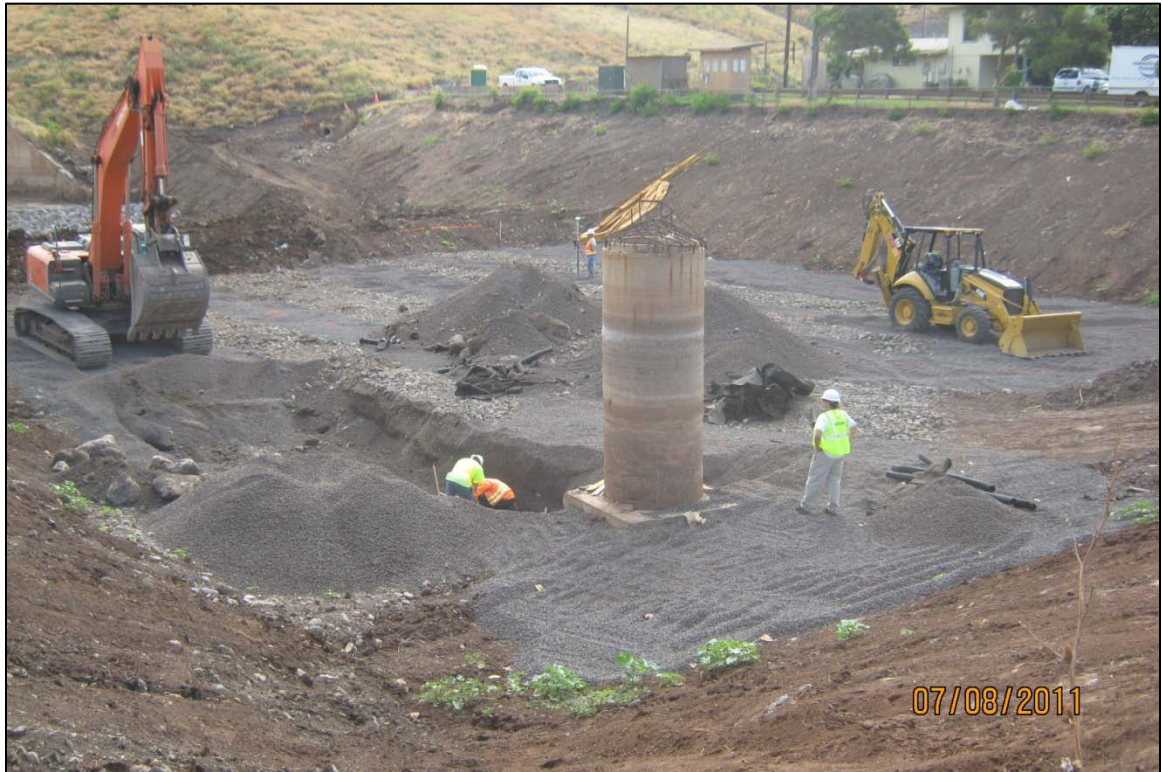
Photo 1: Excavating 4-inch subdrain system for replacement with 6-inch pipe.

During replacement of the 4-inch subdrain pipes, the pipe trenches were excavated and the existing pipes and 16-ounce per square yard (oz/yd<sup>2</sup>) filter geotextile removed and disposed of on site. The 3/4-inch drainage gravel was stockpiled for re-use. Following excavation of the 4-inch subdrain system, the floor of the subdrain trenches were re-graded for proper drainage to the concrete riser vaults and new 16-oz/yd<sup>2</sup> filter geotextile installed. The drainage gravel and perforated 6-inch HDPE pipes were installed as shown on Detail 3 on Drawing C-11 provided in the work plan (Attachment 1).

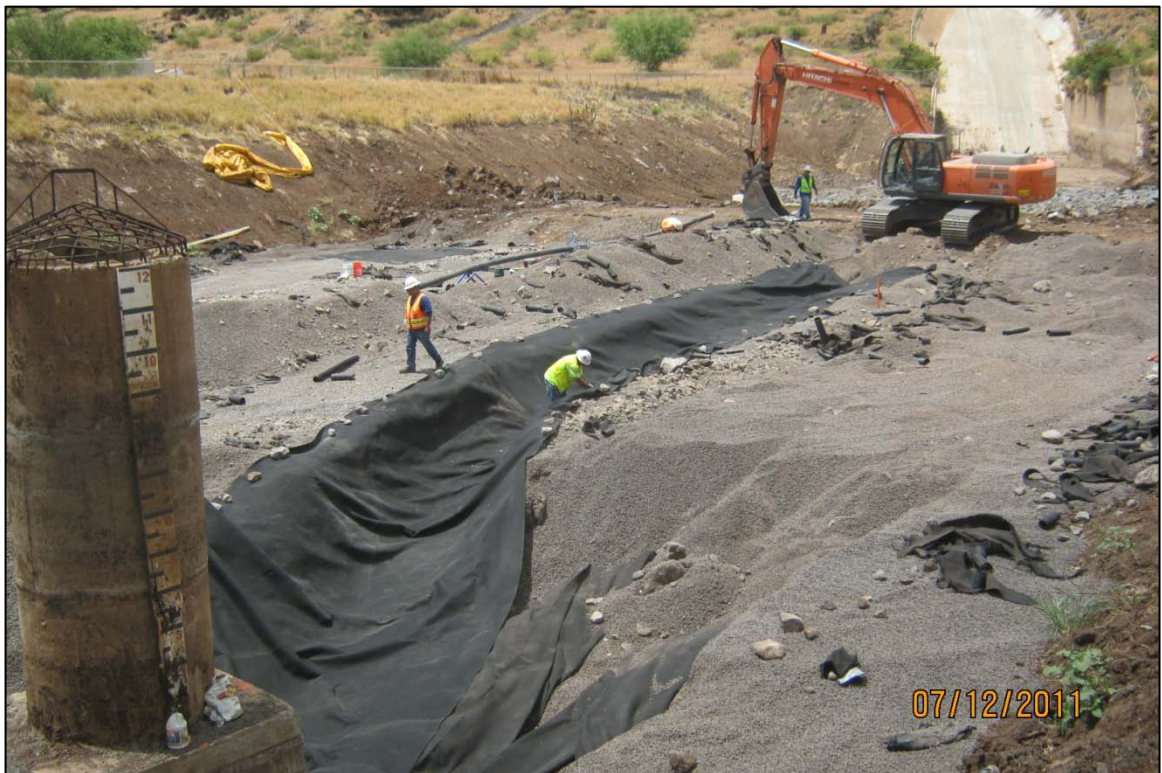
Photo 2: Installing new 16-oz/yd<sup>2</sup> geotextile filter fabric in the subdrain trench.

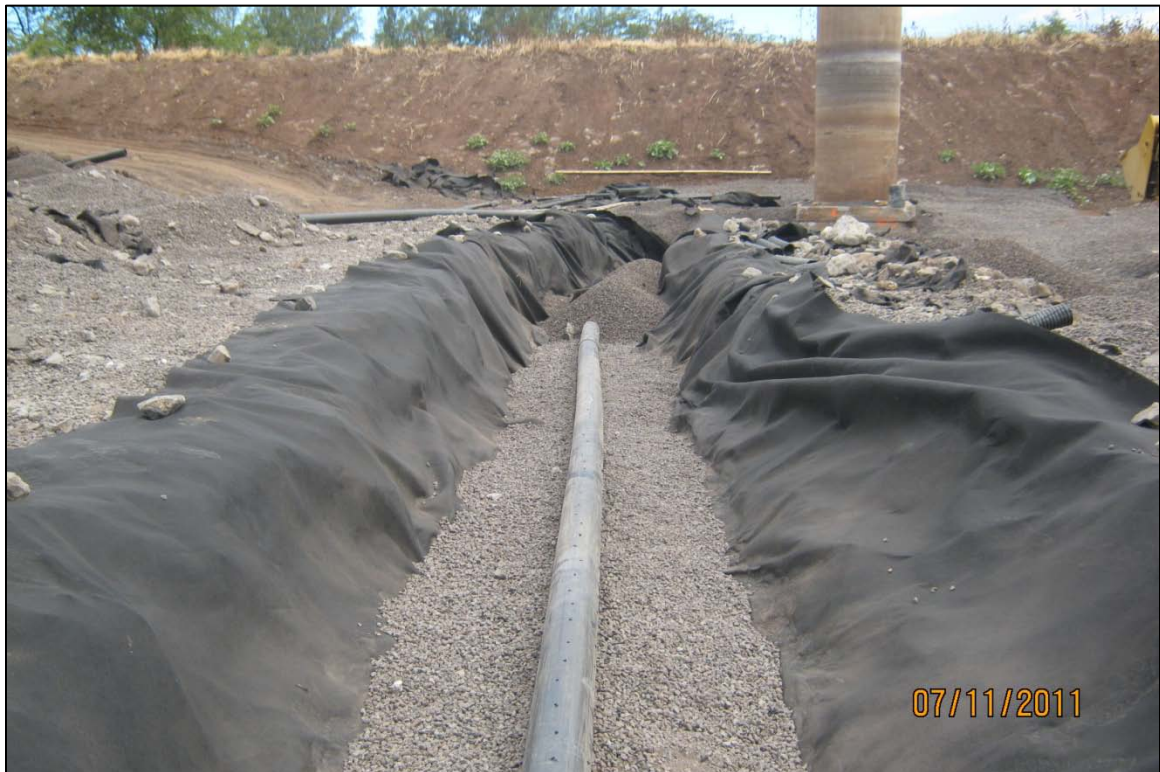
Photo 3: New 6-inch perforated HDPE subdrain pipe encapsulated in drainage gravel and filter fabric.

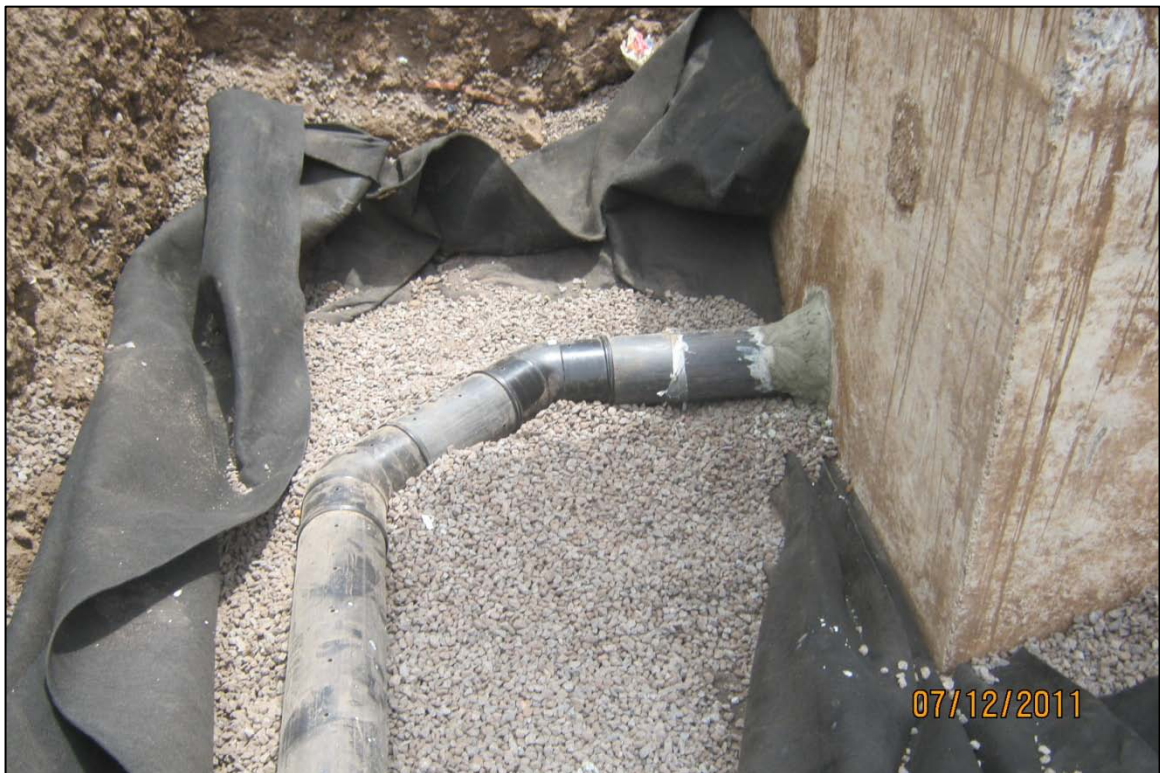
Photo 4: Connection of 6-inch subdrain pipe to the concrete vault.

The upstream (northern) ends of the 6-inch subdrain pipes were capped with a solid end cap and the downstream (southern) ends of the pipes were grouted into the concrete riser vaults using a Quickcrete mix.

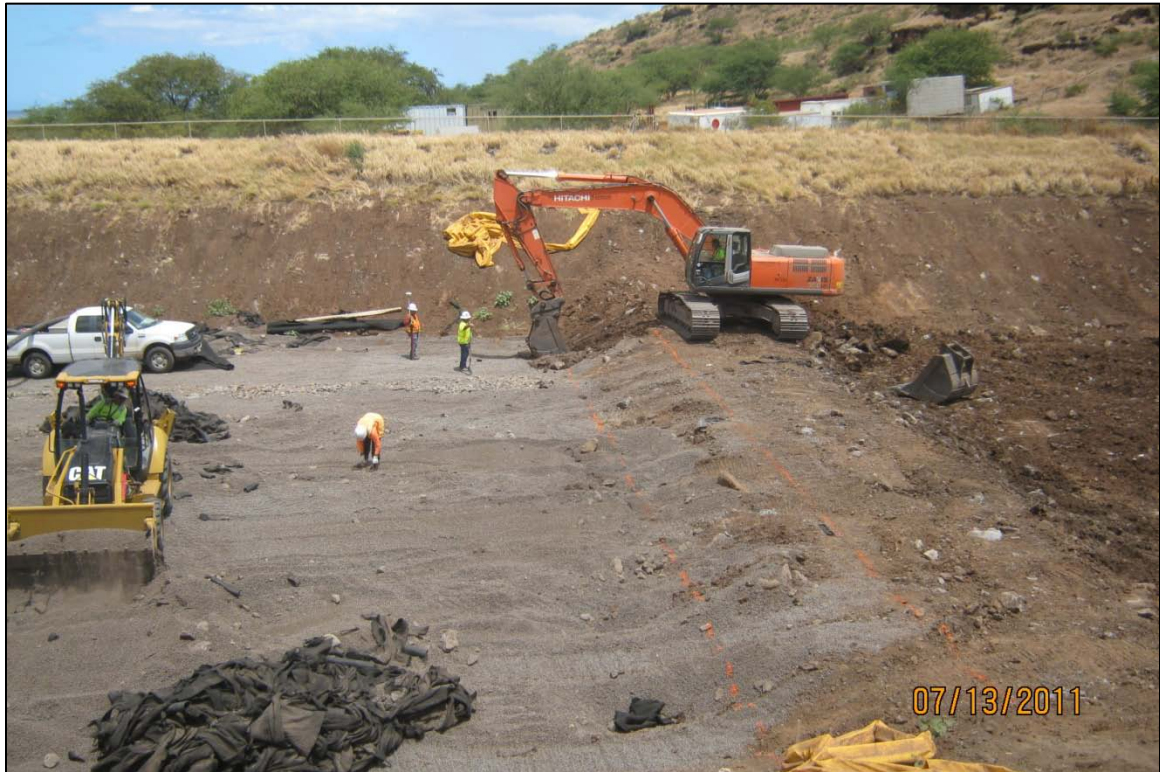
Photo 5: Grading the interior berm prior to placement of grouted rock rip-rip (GRP) exterior, looking west.

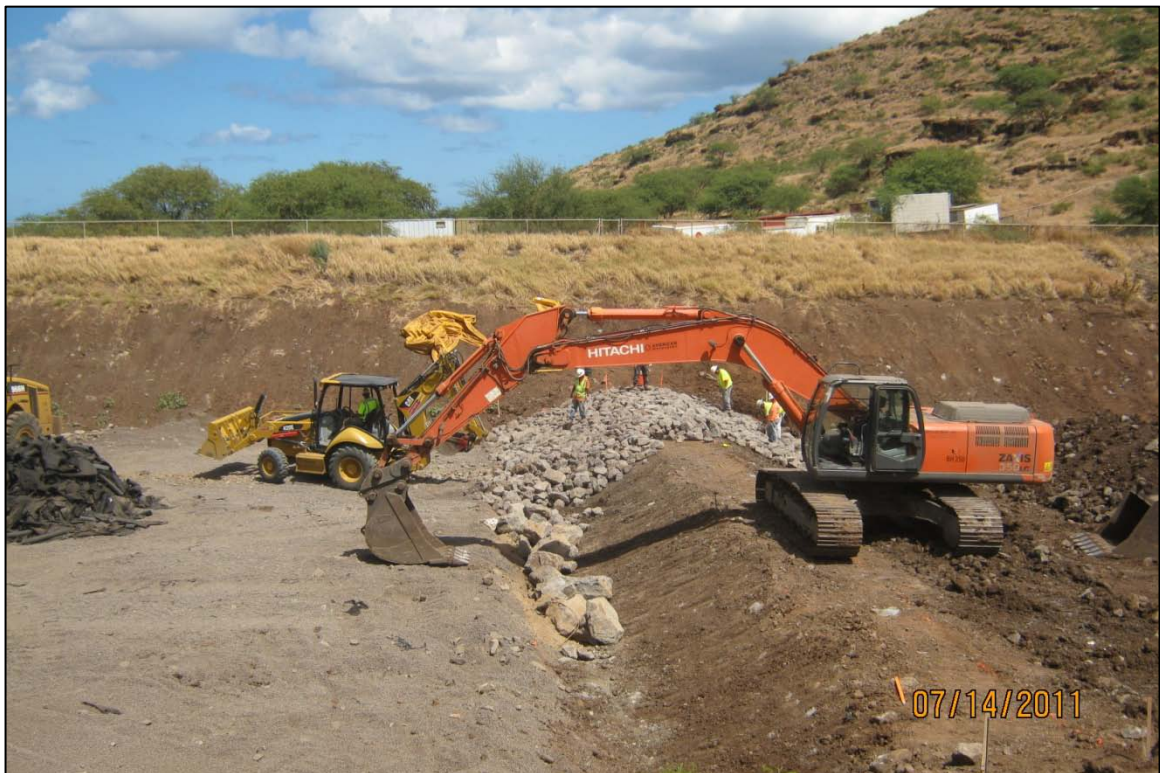
Photo 6: Placing rock along the interior berm to form the GRP exterior, looking west.

Onsite generated rocks (~12–24 inches in diameter) were used to layer the berm and establish design grades for the interior berm. A 2,500 pound per square inch strength fine grout material was pumped into the voids between the rocks and completed the GRP exterior on the interior berm.

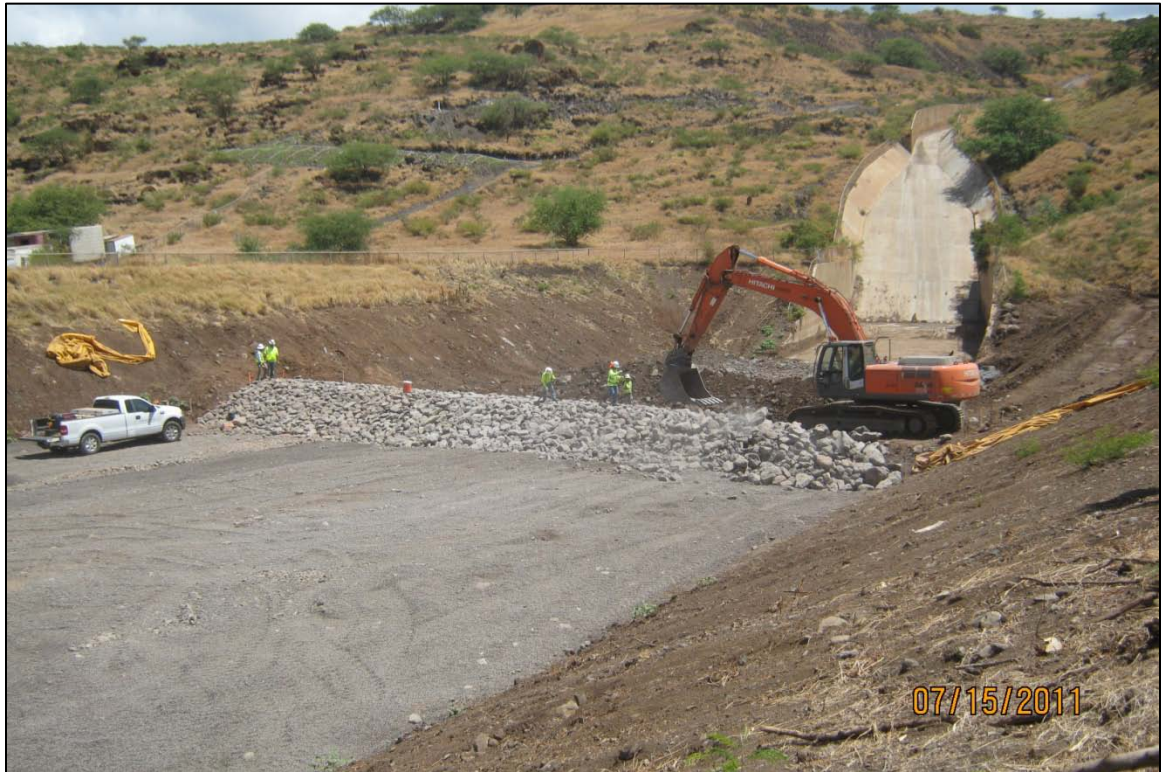
Photo 7: Completing placement of the rock along the interior berm, looking north.

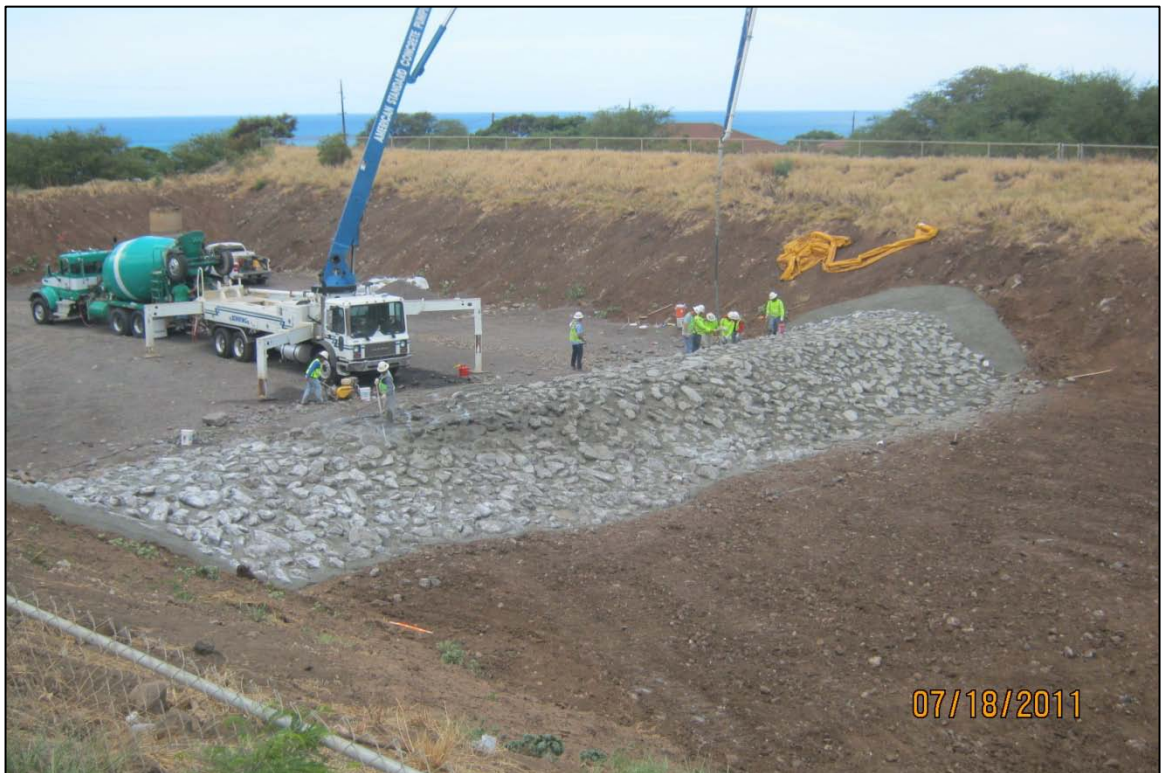
Photo 8: Pumping grout between rocks along the interior berm to complete the GRP exterior.

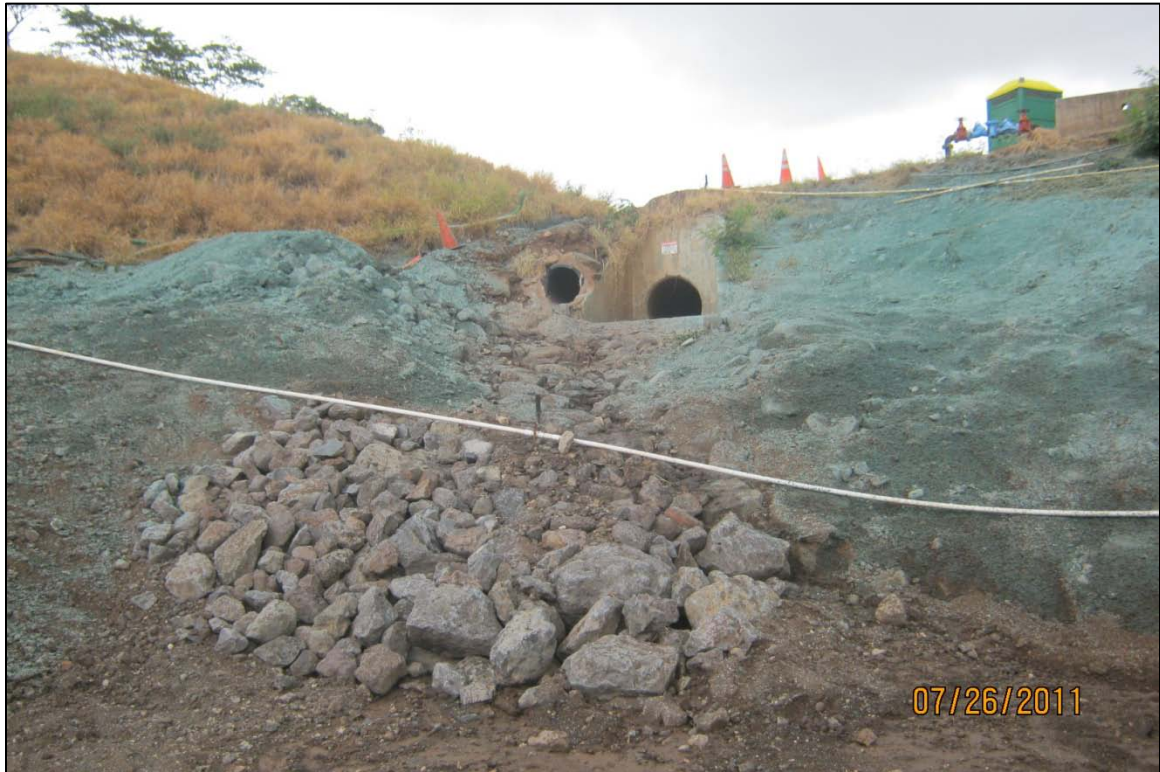
Photo 9: 18- and 24-inch outfalls in the north eastern corner of the sedimentation basin following removal of access ramp and exposure of rock rip-rap.

Following restoration of the interior berm, the access ramps into the northern and southern portions of the basin were removed. In the northern portion of the basin, this included exposing the remaining portions of the rip-rap energy dissipater at the 18-inch and 24-inch stormwater pipe outfalls. Additional rock was placed near the basin floor below the outfalls

and soil was removed from the existing rock to provide a continuous rock rip-rap from the outfalls to the floor of the basin.

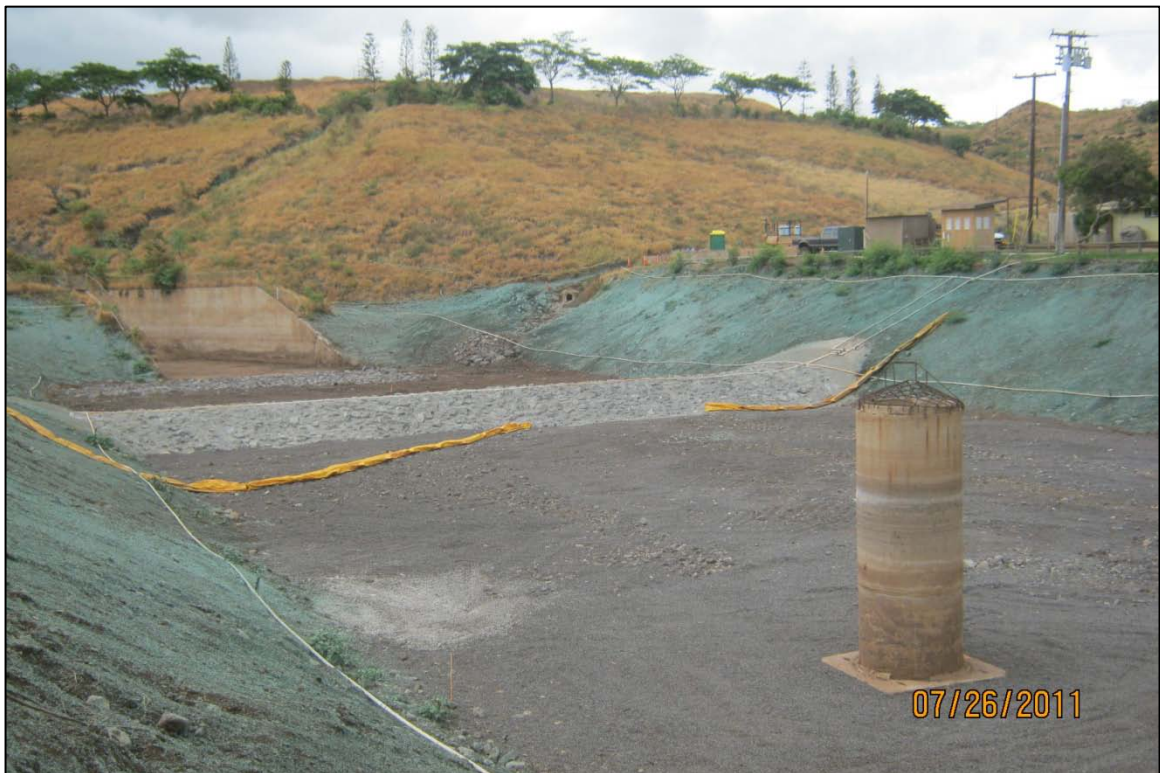
Photo 10: Sedimentation basin looking northeast following completion of restoration activities.
